BRANT LAKE UPPER DAM

WARREN COUNTY, NEW YORK  
INVENTORY No. NY 158

PHASE I INSPECTION REPORT  
NATIONAL DAM SAFETY PROGRAM

UPPER HUDSON RIVER BASIN  
BRANT LAKE UPPER DAM  
I.D. No. NY - 158 (#652)  
PHASE 1 INSPECTION REPORT

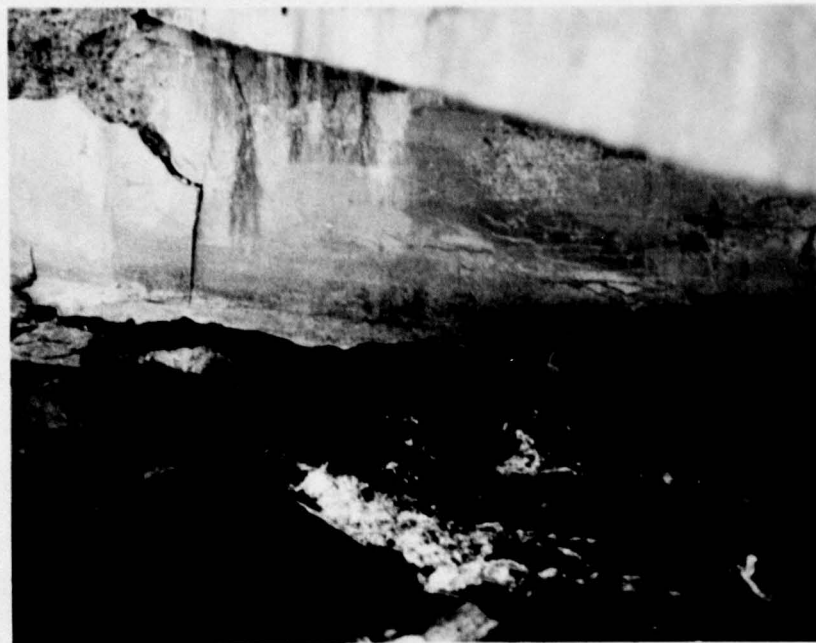
There are concrete wingwalls on either side of both abutments. The wall on the east side of the upstream face (northeastern wall) is in poor condition. The flow of water has cut into the face of the wall and has undermined the toe slightly. This wall retains an area where the soil section is widest and so it is unlikely that failure of the wall would endanger the dam or allow the water to flow around the end of the structure.

Visual observation of the dam did not reveal any signs of major distress. The spillway section, the abutments, and the wingwalls all appeared to be relatively stable. The only problem noted was the undermining near the point where the east abutment joins the northeast wingwall. Further undermining in this area could result in a stability problem.

Scour Hole At East Abutment

NORTHEAST WINGWALL @ ABUTMENT - HOLE & UNDERMINED @ WATER SURFACE  
FASCIA CONCRETE - SPALLED ( $\pm 40\%$  -  $50\%$ )

- a. Investigate the concrete spillway section to determine the exact limits and dimensions of the concrete, and using this information reassess the stability of the dam.
- b. Fill the void which exists at the eastern end of the spillway under the bridge abutment.
- c. Repair the deteriorated concrete on the northeastern wingwall.
- d. Repair or replace the highway bridge crossing the dam.
- e. Establish a program of periodic inspections of the dam.
- f. Maintain a record of maintenance of the dam.
- g. Develop and place in readiness a warning system for possible future use during periods of unusually heavy precipitation.
